2.0 FARM OPERATION AND PROPANE SYSTEM

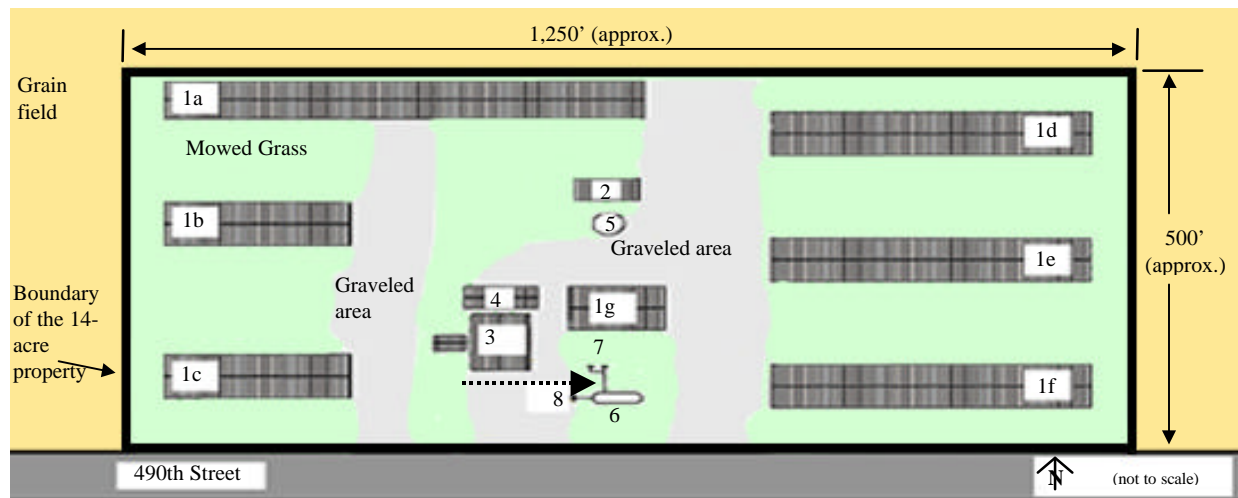
Figure 2. Plot Plan of Farm, 2243 490th Street, Albert City, Iowa

1. Direct-fired vaporizers (Item 7) are located approximately 37 ft north of the 18,000-gallon propane tank (Item 6).
2. Fueling truck point-of-transfer (Item 8) is located approximately 40 ft west of the 18,000-gallon propane tank (Item 6).
3. South side of turkey barn 1g is approximately 87 ft north of the 18,000-gallon propane tank (Item 6).
4. Centerline of 490th Street is approximately 78 ft south of the 18,000-gallon propane tank (Item 6).

The propane tank, which was made of carbon steel, was approximately 42 feet long and 9 feet in diameter. It was located approximately 78 feet north of the 490th Street centerline (see Figure 2, item 6). The tank rested on two concrete saddles with the bottom of the tank located approximately 4 feet above ground level. Figure 3 is a view of the tank looking north from 490th Street.

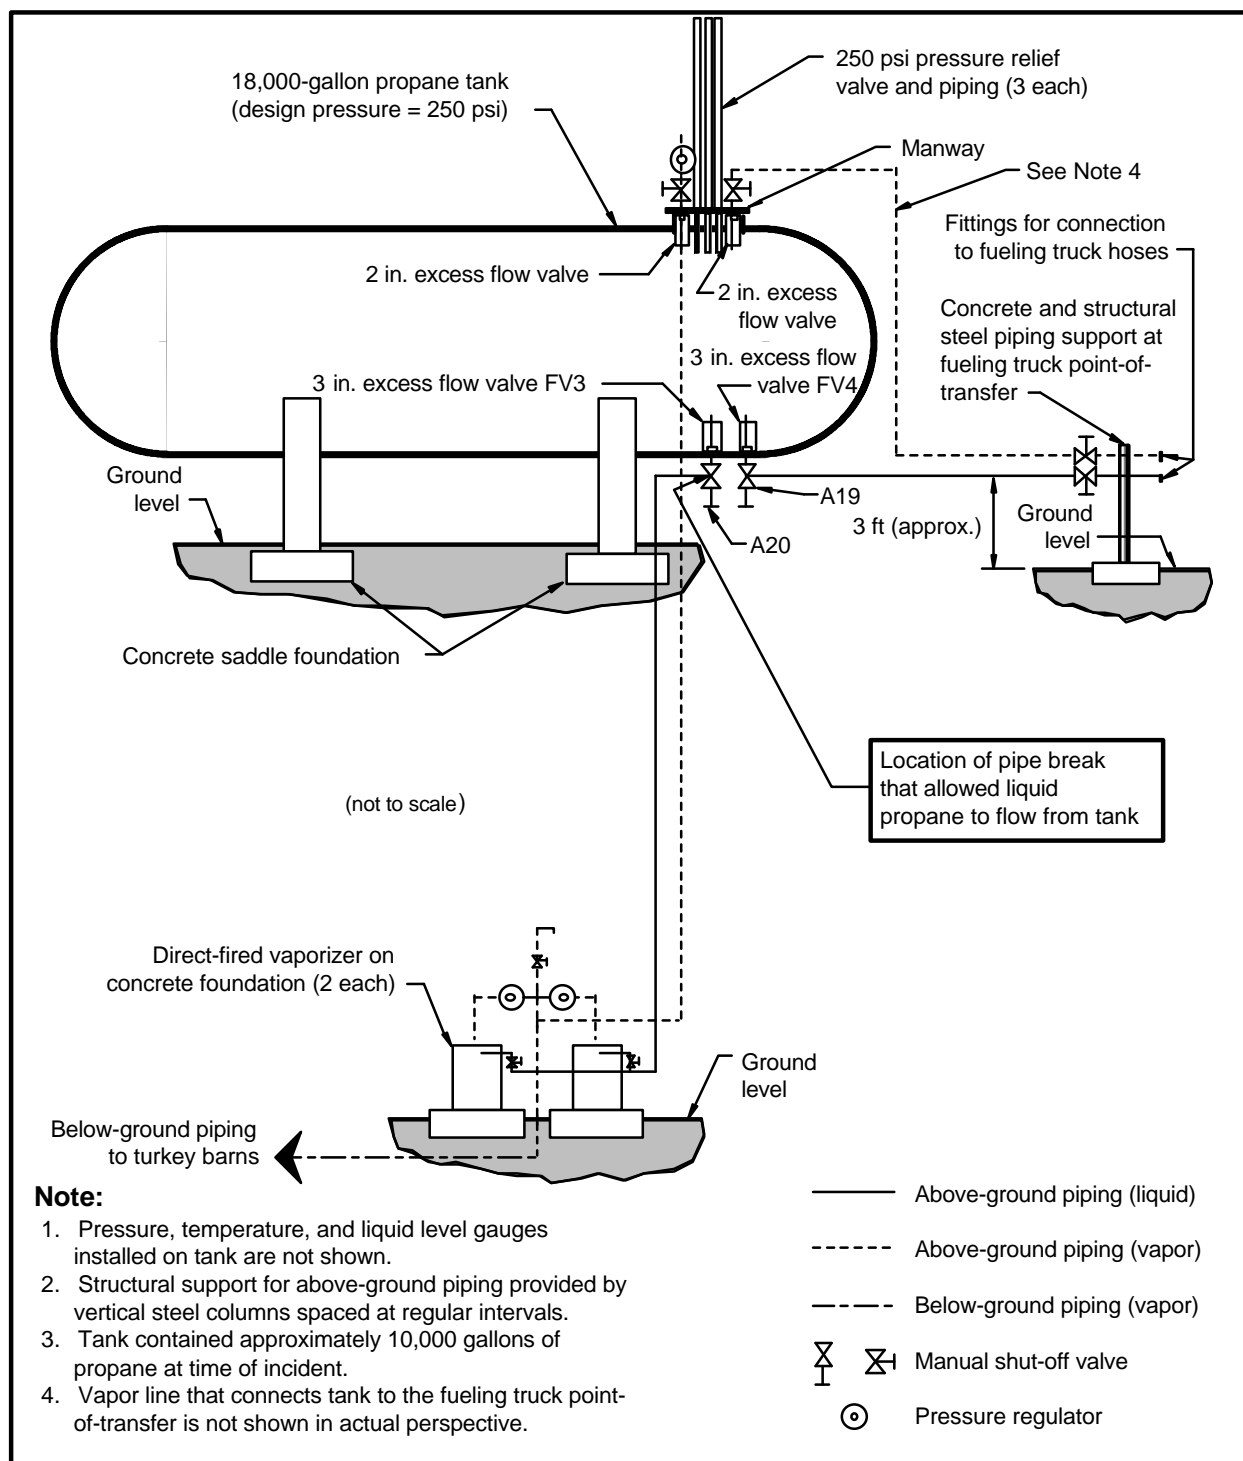
Figure 6. Piping Diagram for the Propane Storage and Handling System

During normal operations, liquid propane was withdrawn from the tank through the 3-inch excess flow valve (FV3 in Figure 6), past the open shut-off valve (A20 in Figure 6), and then into the ¾-inch outlet pipe to the vaporizers shown in Figure 7. These vaporizers used heat to convert the liquid propane into a gas. After passing through a pressure regulator, the propane gas was piped underground to the various space heaters and furnaces located in the buildings on the farm.
